Hullavington Flood Sites

Compiled by Cllr Jon Atkey and Cllr Debbie Lawley

5 August 2025. Updated 11 September 2025

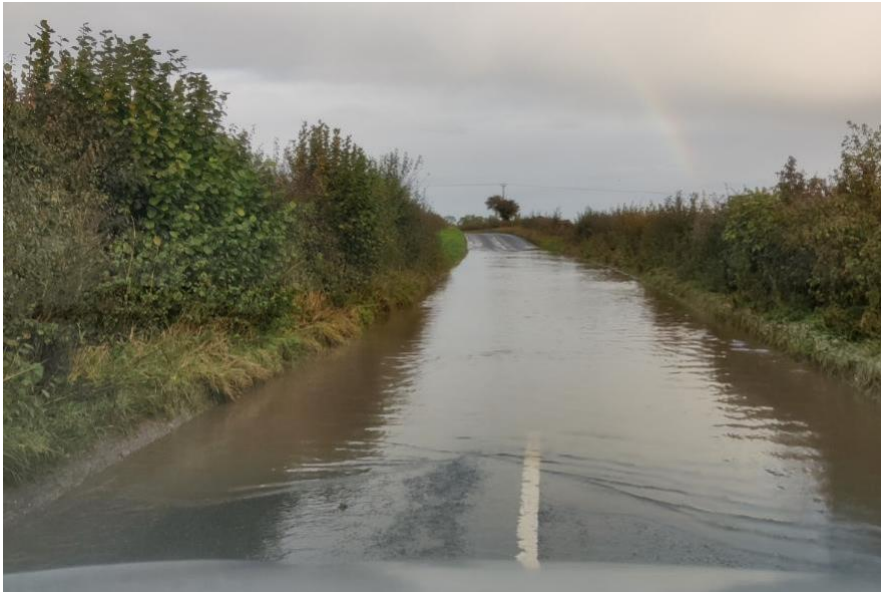
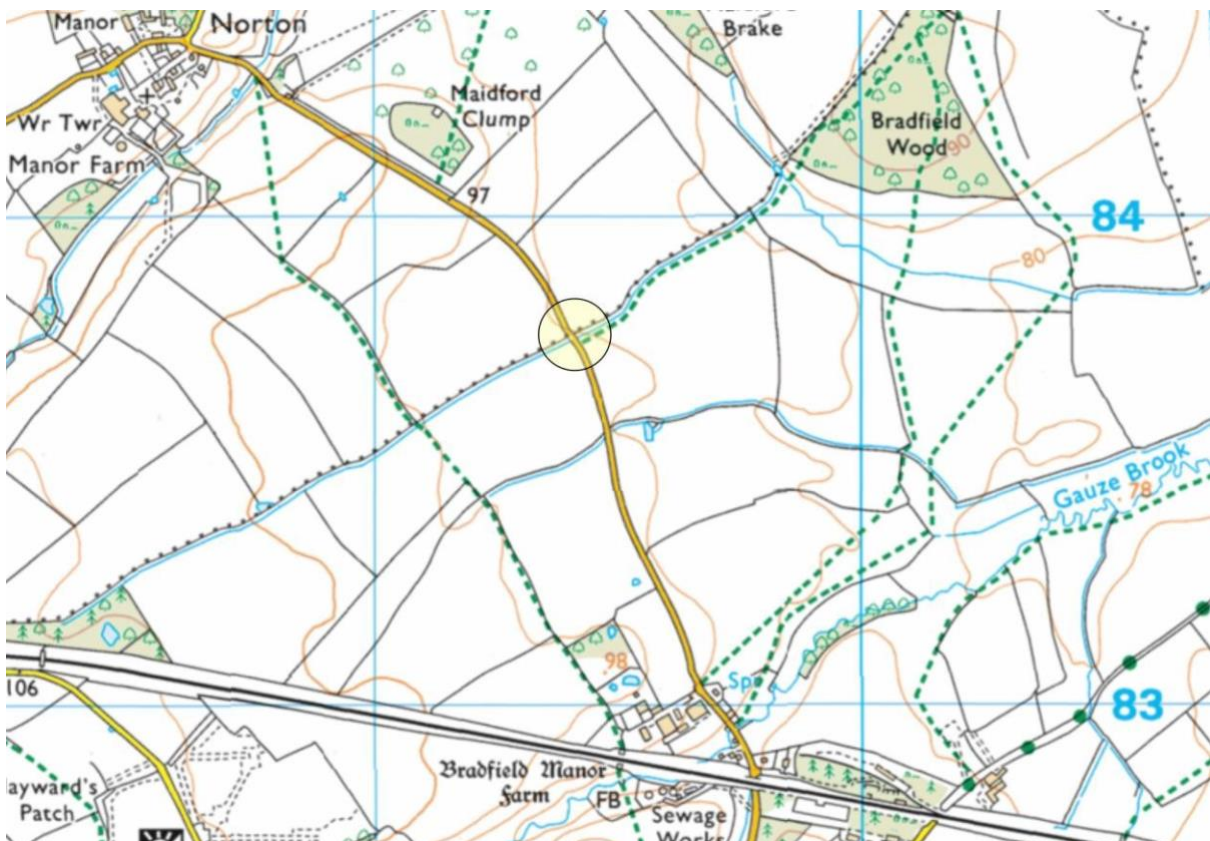
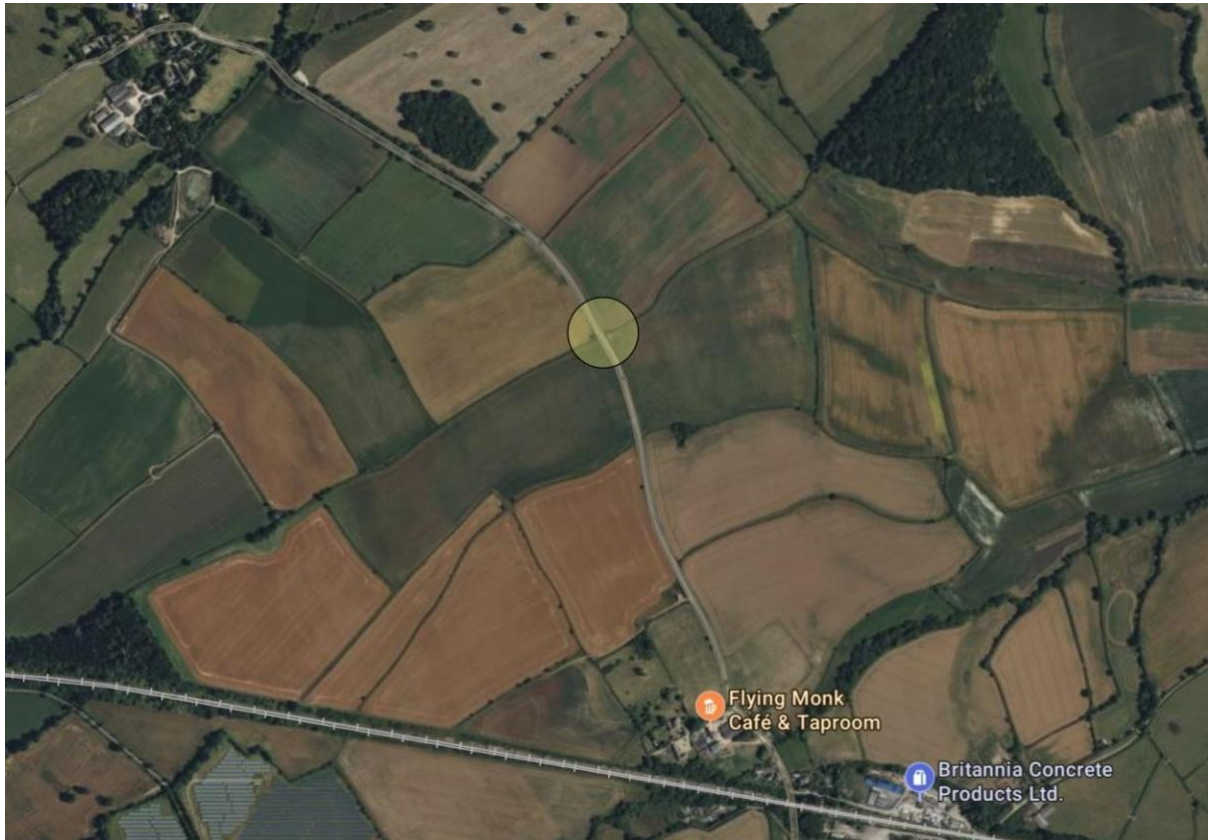
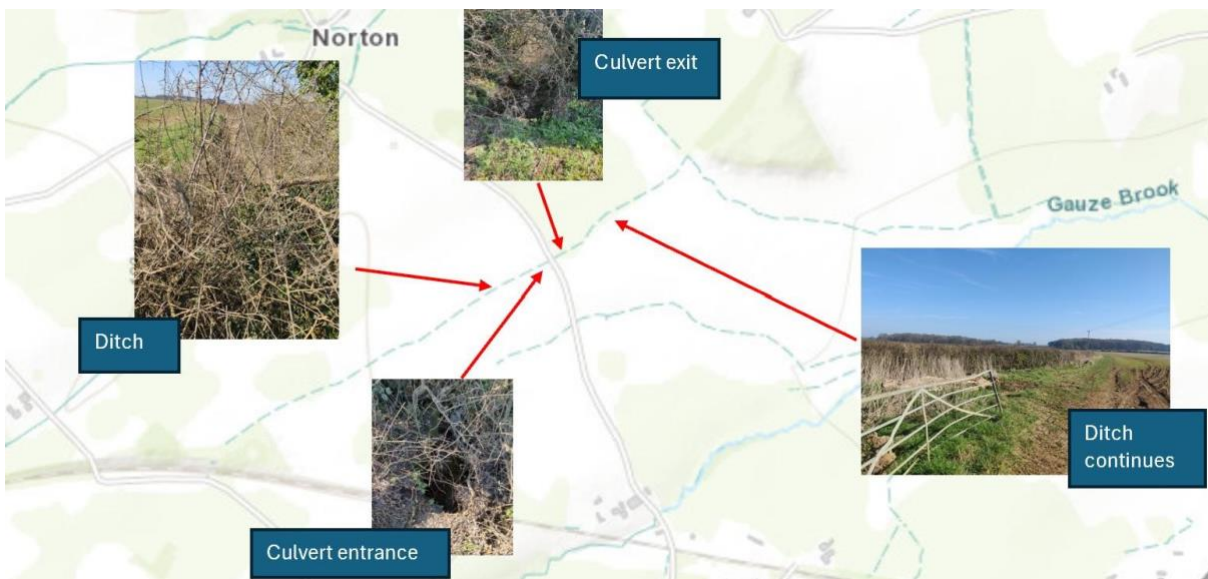
1.Road between Hullavington and Norton (1)

A culvert under the road with additional drainage gullies on the road. Tends to flood during heavy rain. Sometimes impassable to normal traffic.

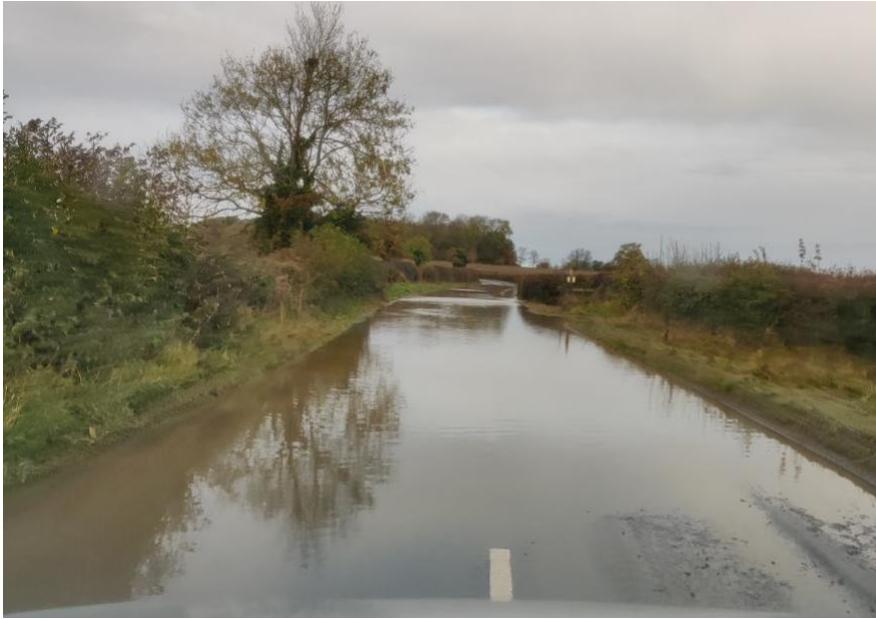
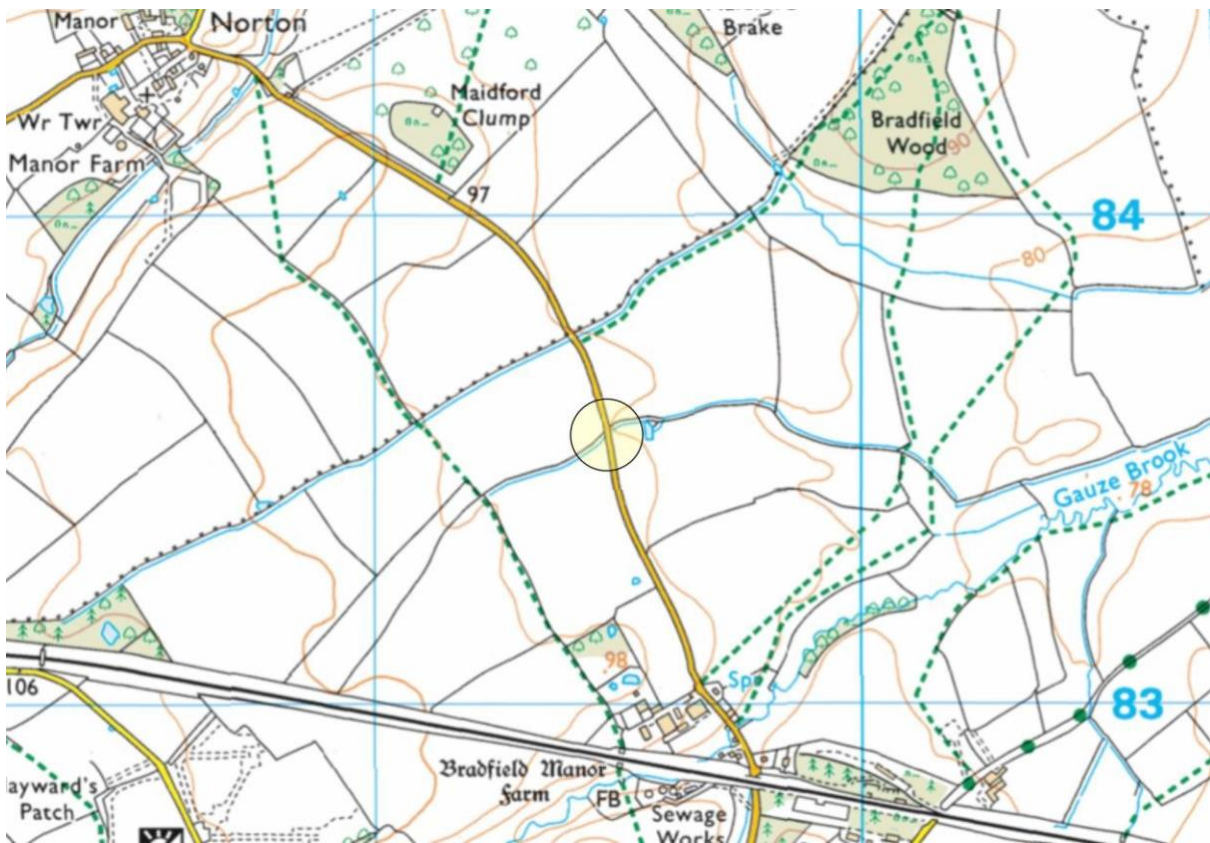
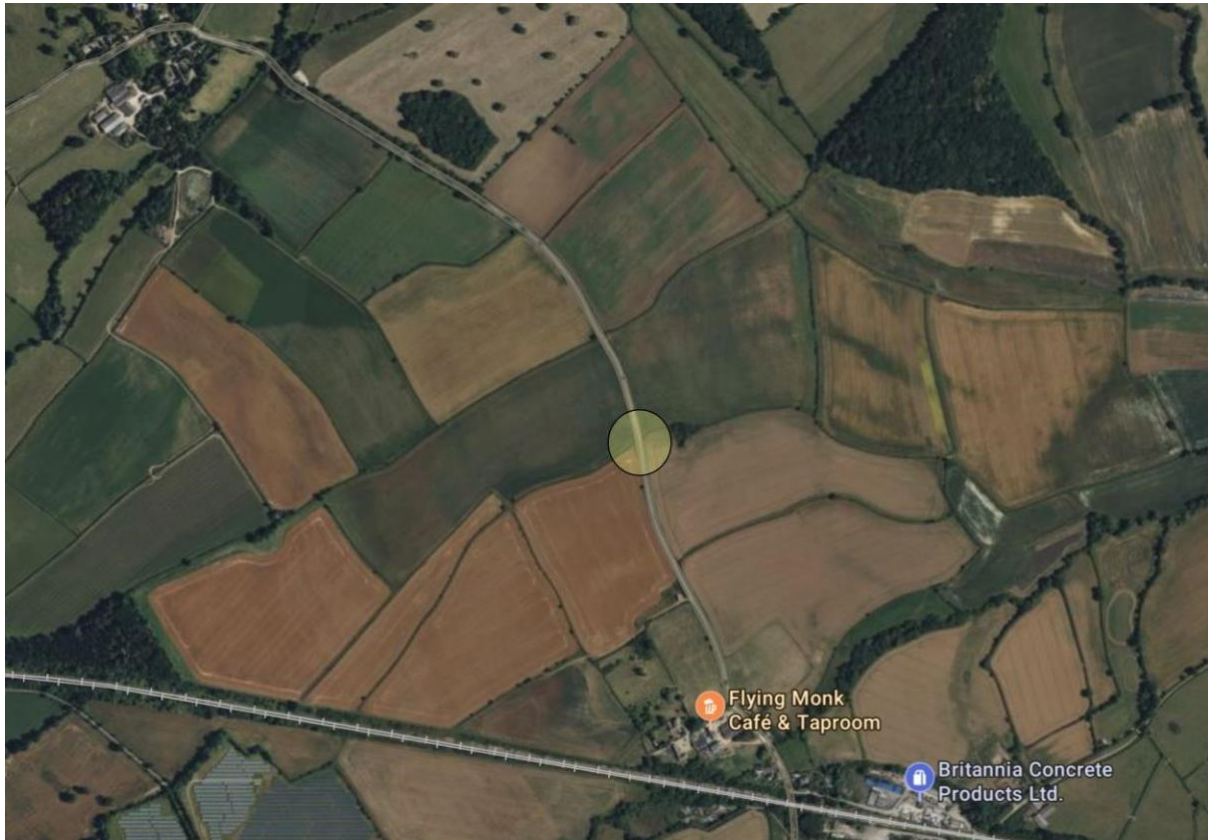
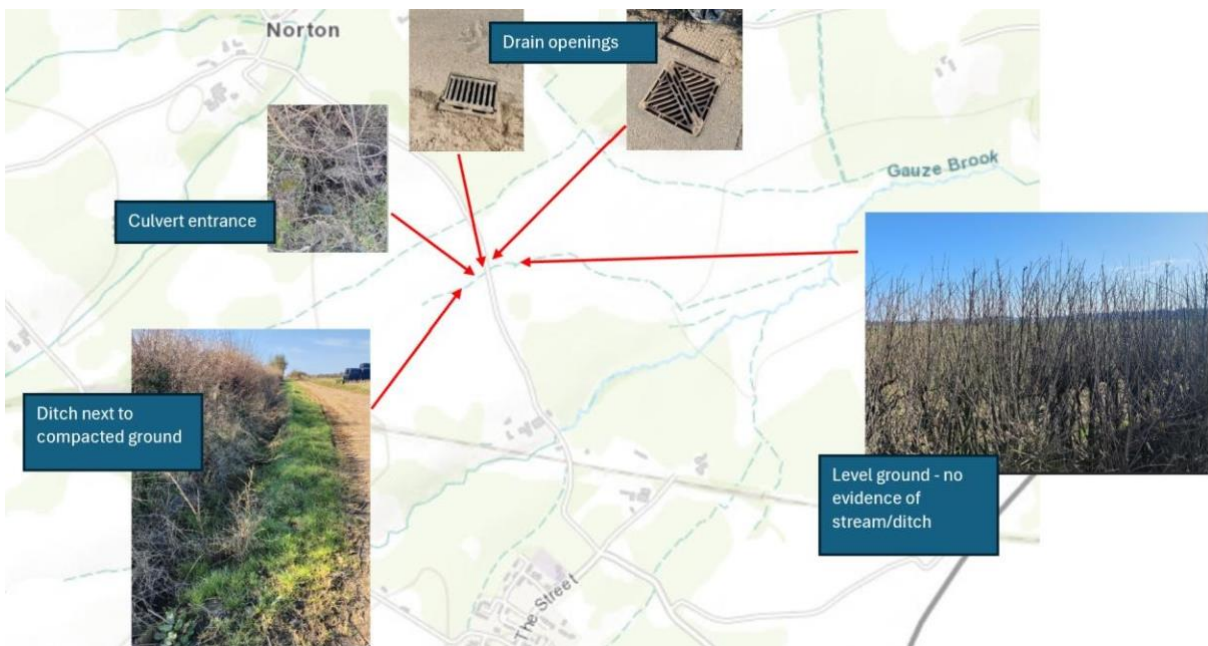
2.Road between Hullavington and Norton (2)

A culvert under the road with additional drainage gullies on the road. Tends to flood during heavy rain. Sometimes impassable to normal traffic.

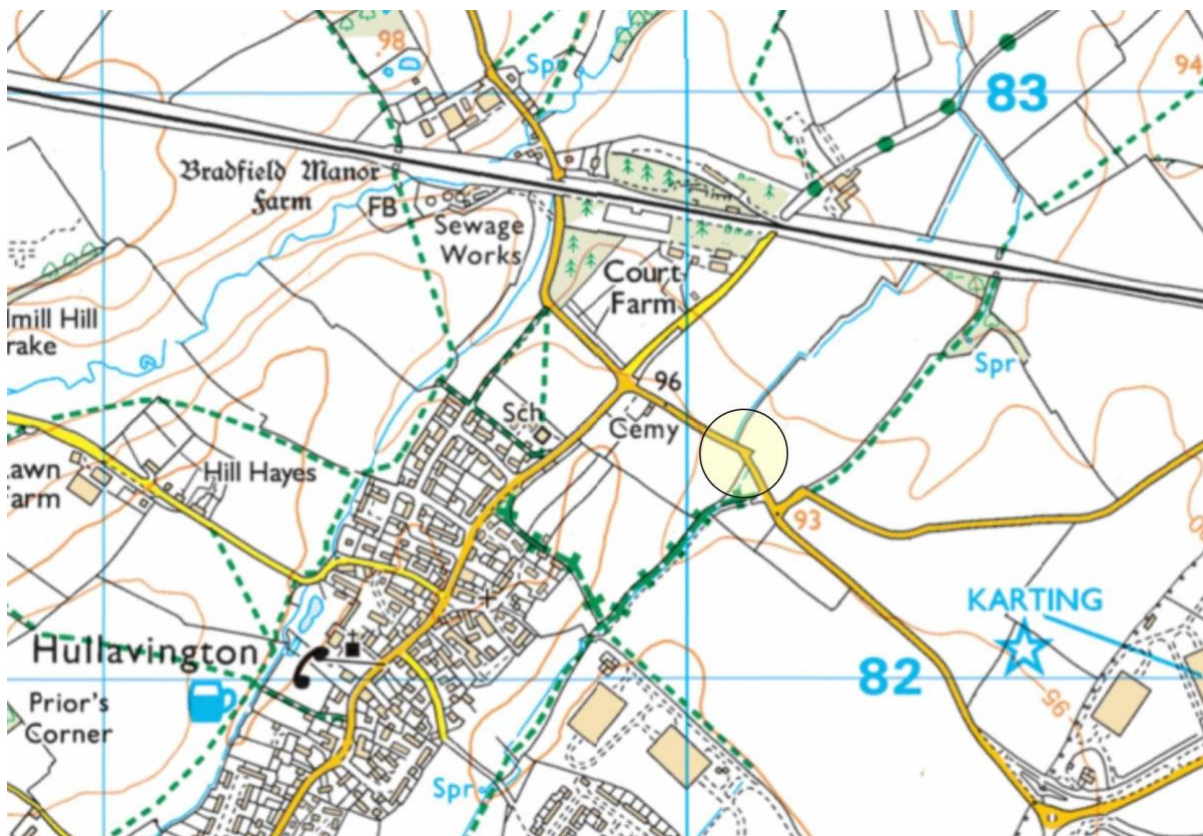
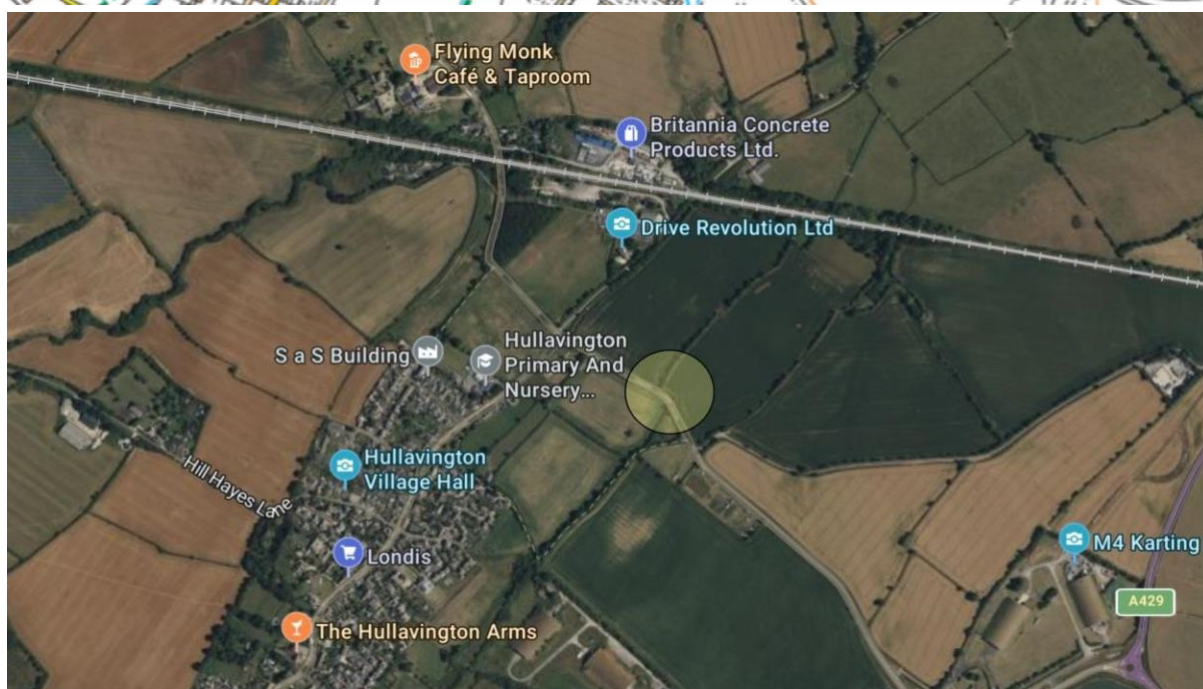
3. Near the Cemetery

A culvert that runs along a section of road, with brick-built entrance and exit. The road here can flood during heavy rain. Becoming impassable for normal road traffic.

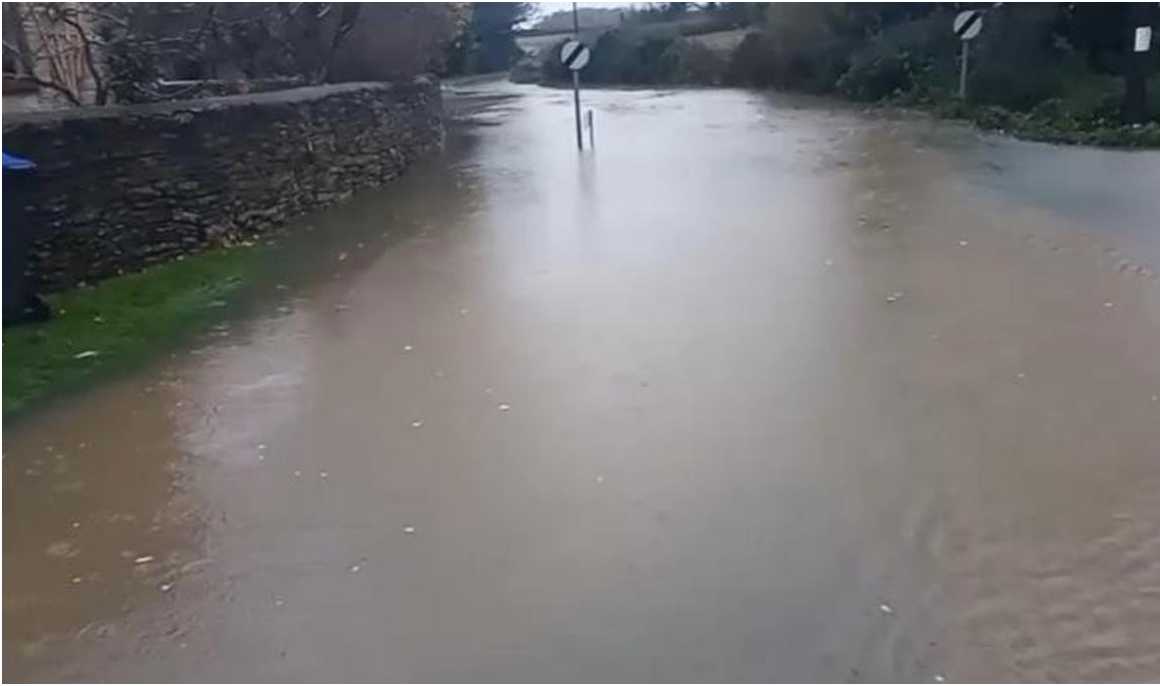
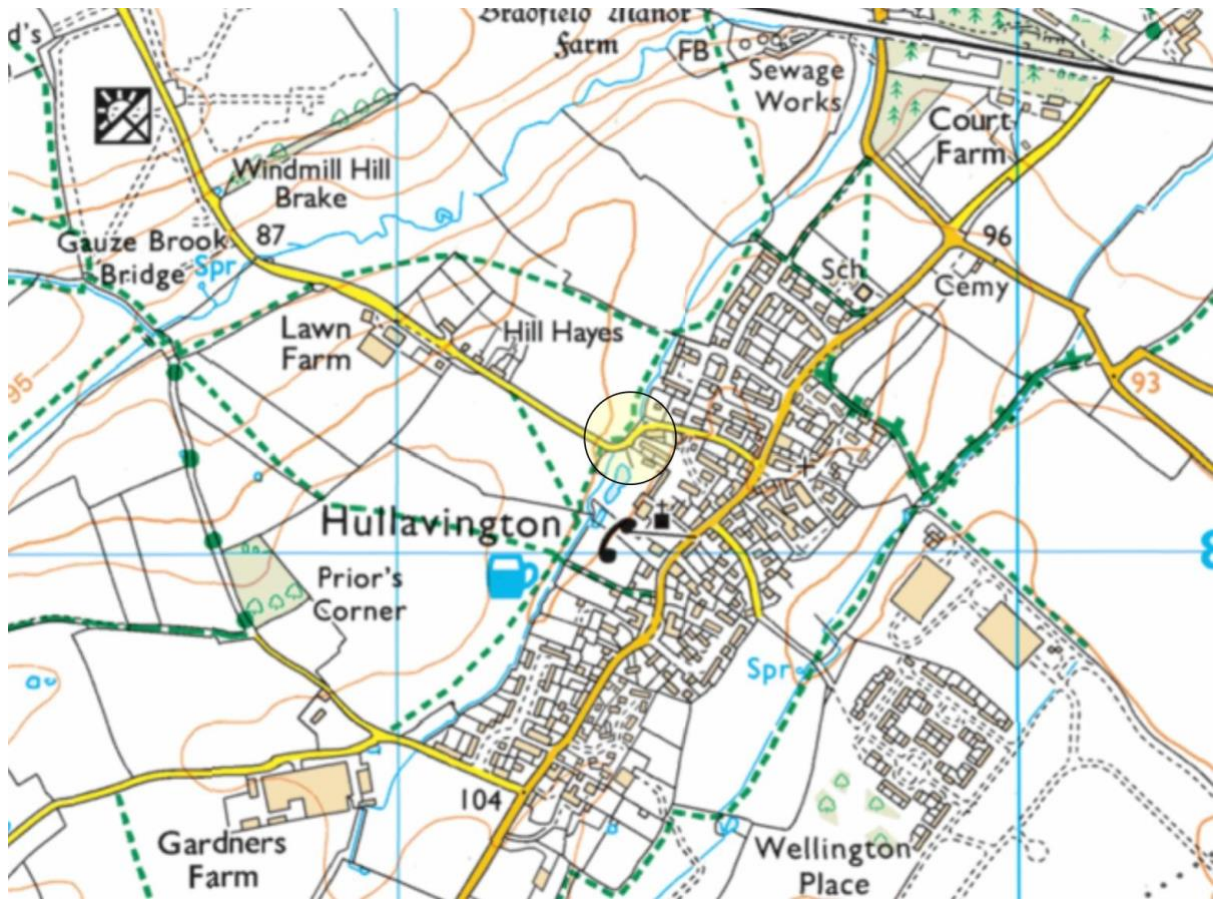
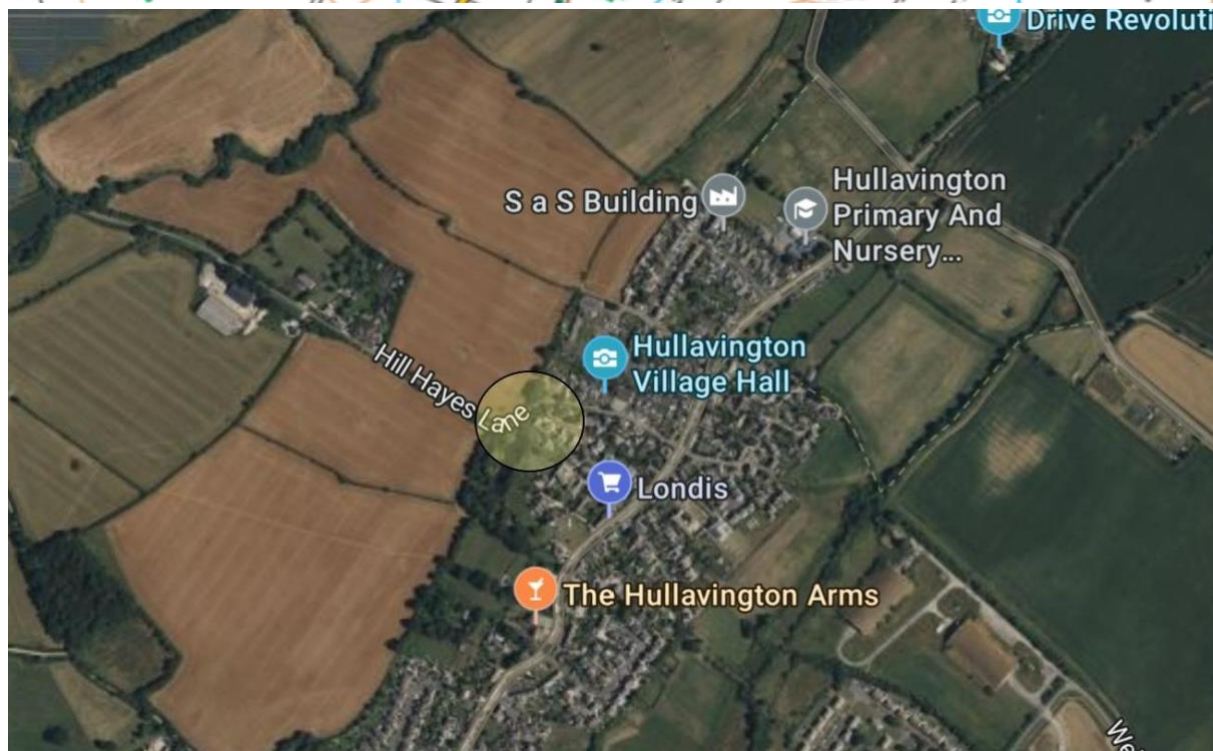
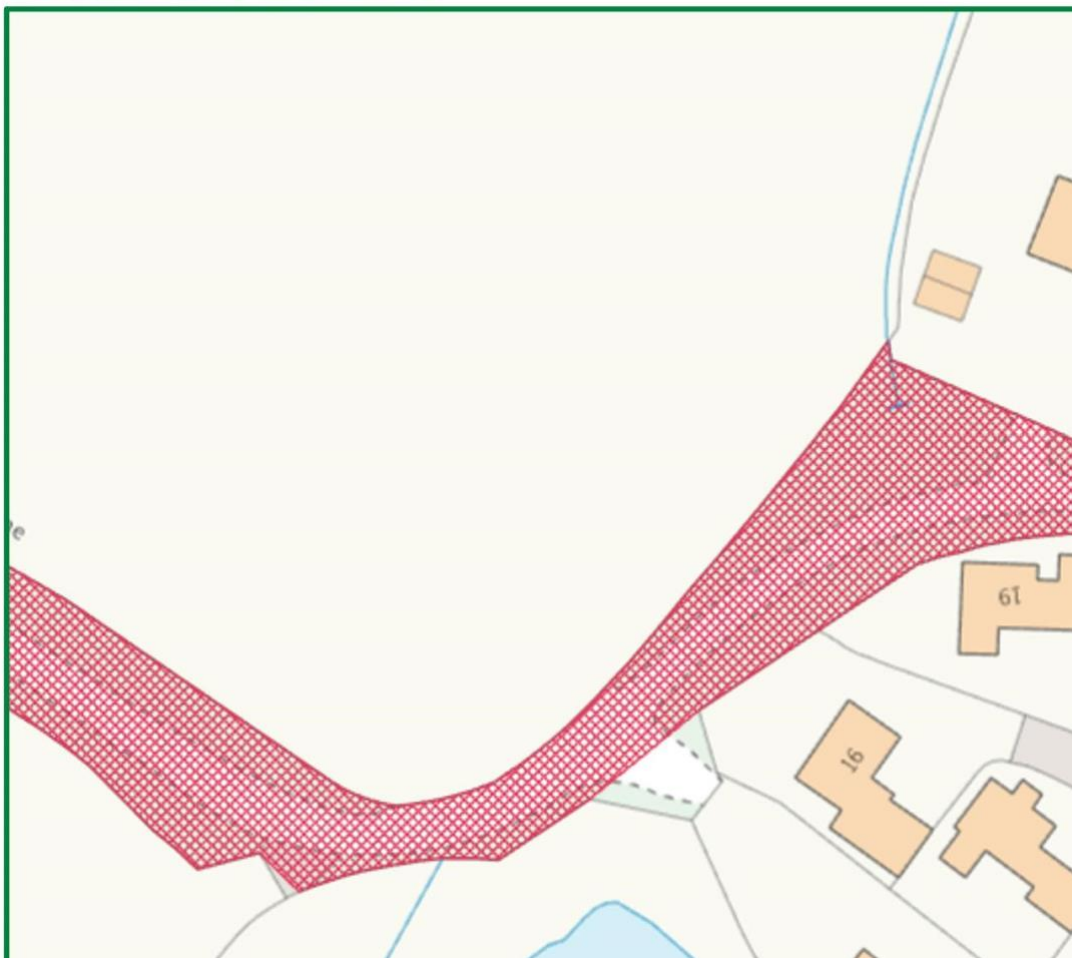
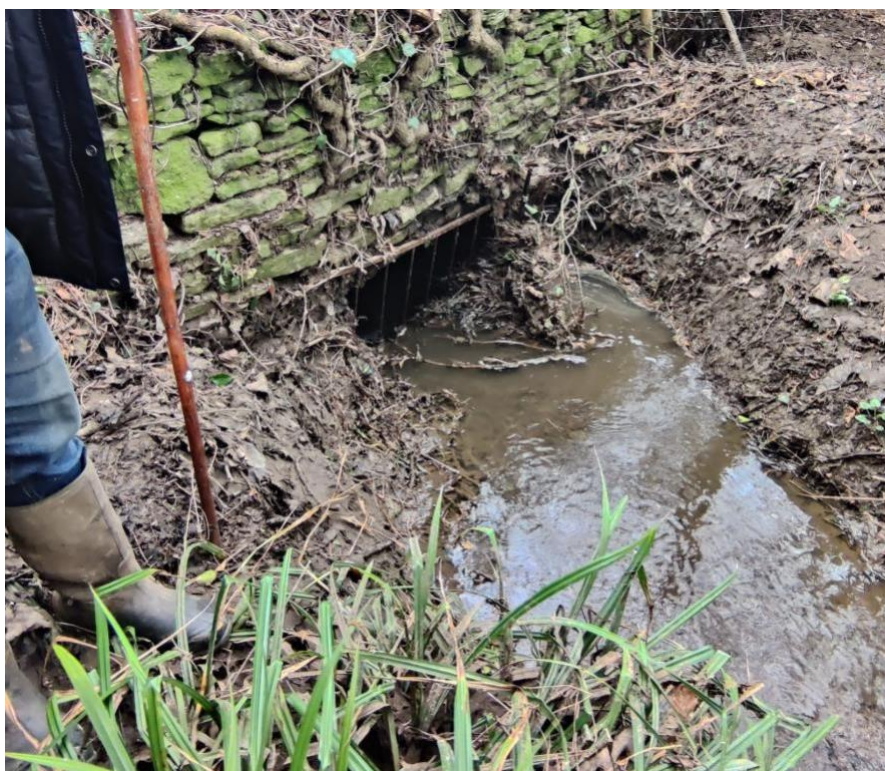
4. Hill Hayes Lane, village edge

A long culvert with its entrance inside the grounds of the Manor House. It runs under a length of road to emerge on Council adopted land next to a bend in the road. The entrance to the culvert has a vertical grill, which often gets blocked with debris. This whole section of road tends to flood during heavy rain.

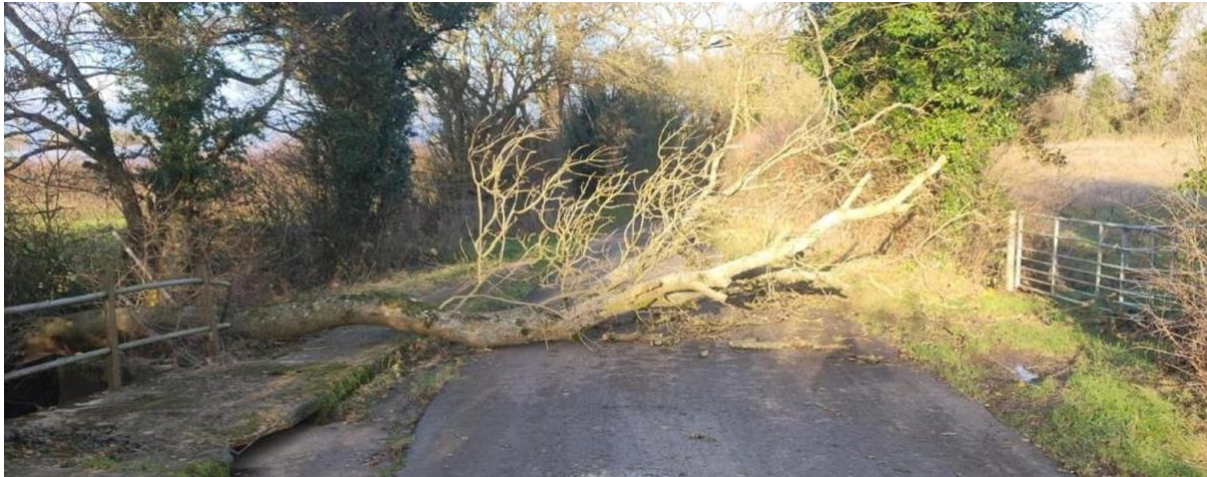
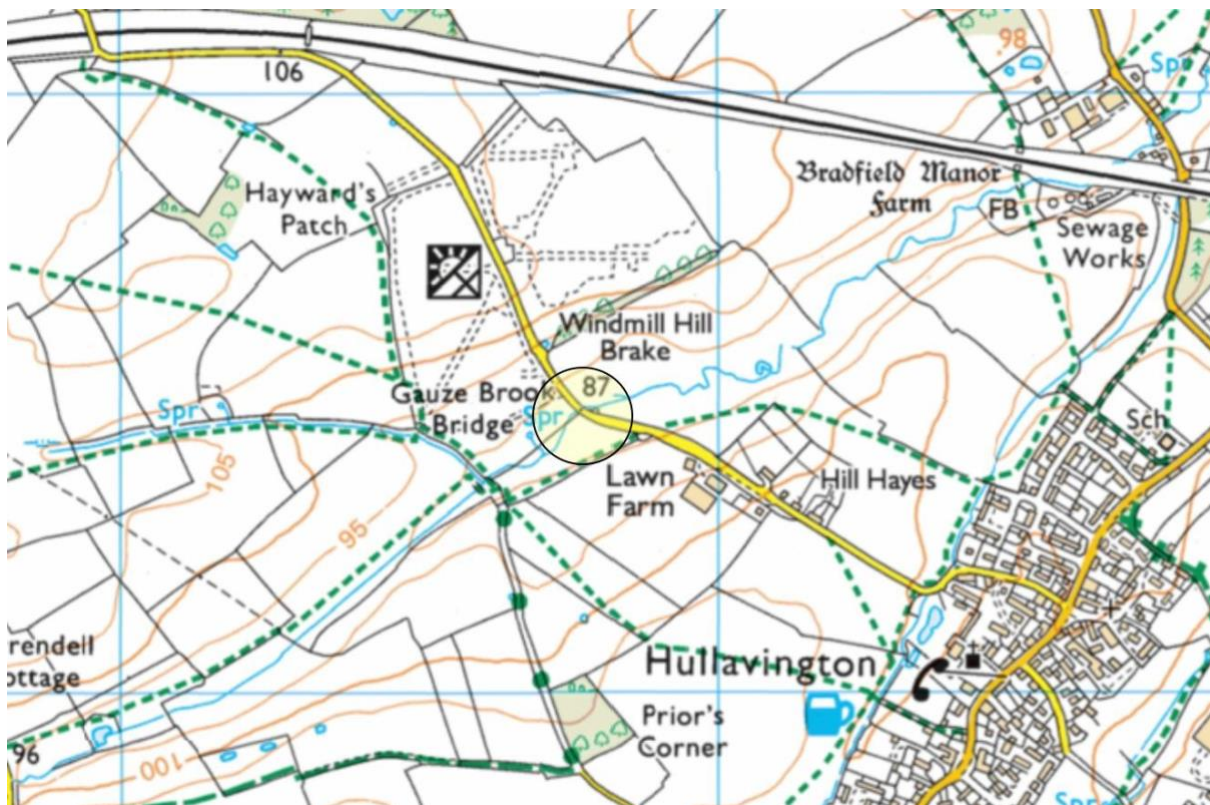
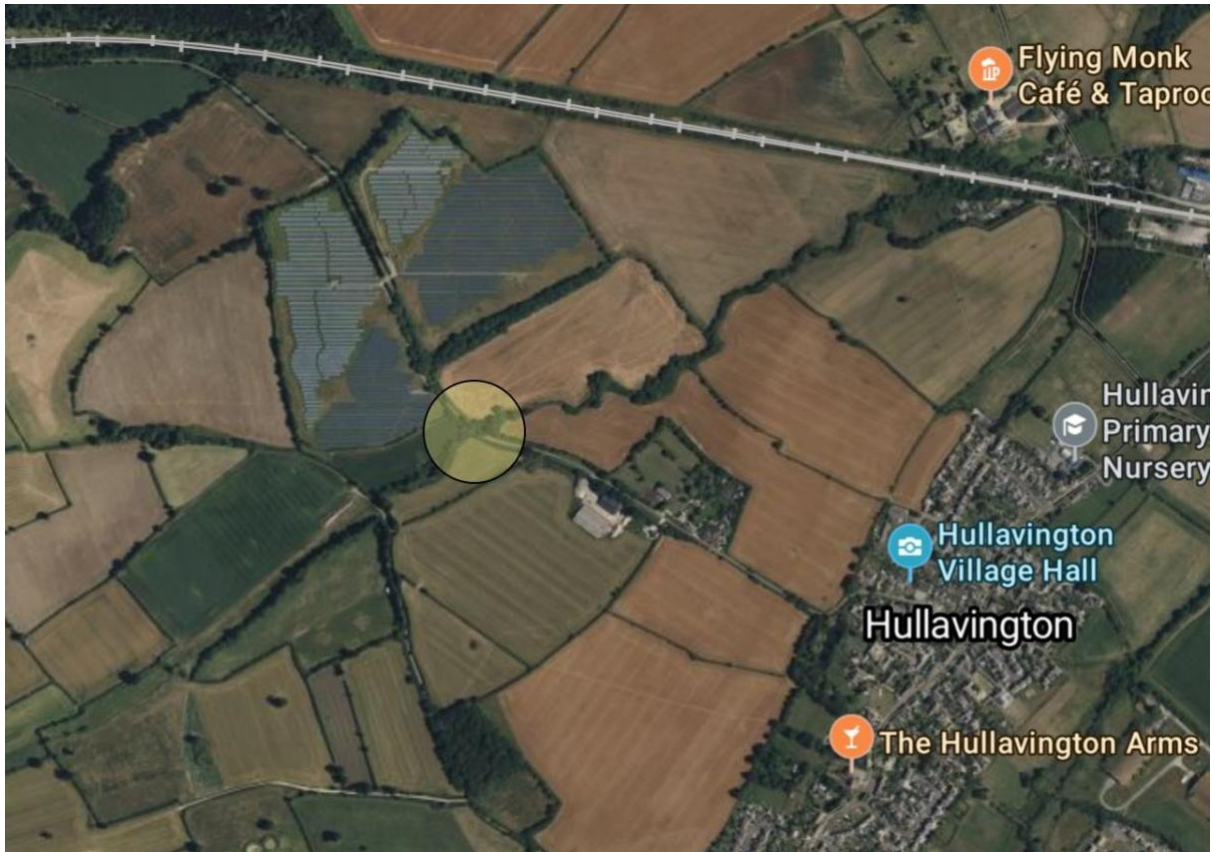
5. Gauze Brook Culvert, Hill Hayes Lane

The culvert is full of debris, causing flooding across the road during heavy rainfall.

The rusted and broken railings need replacing.

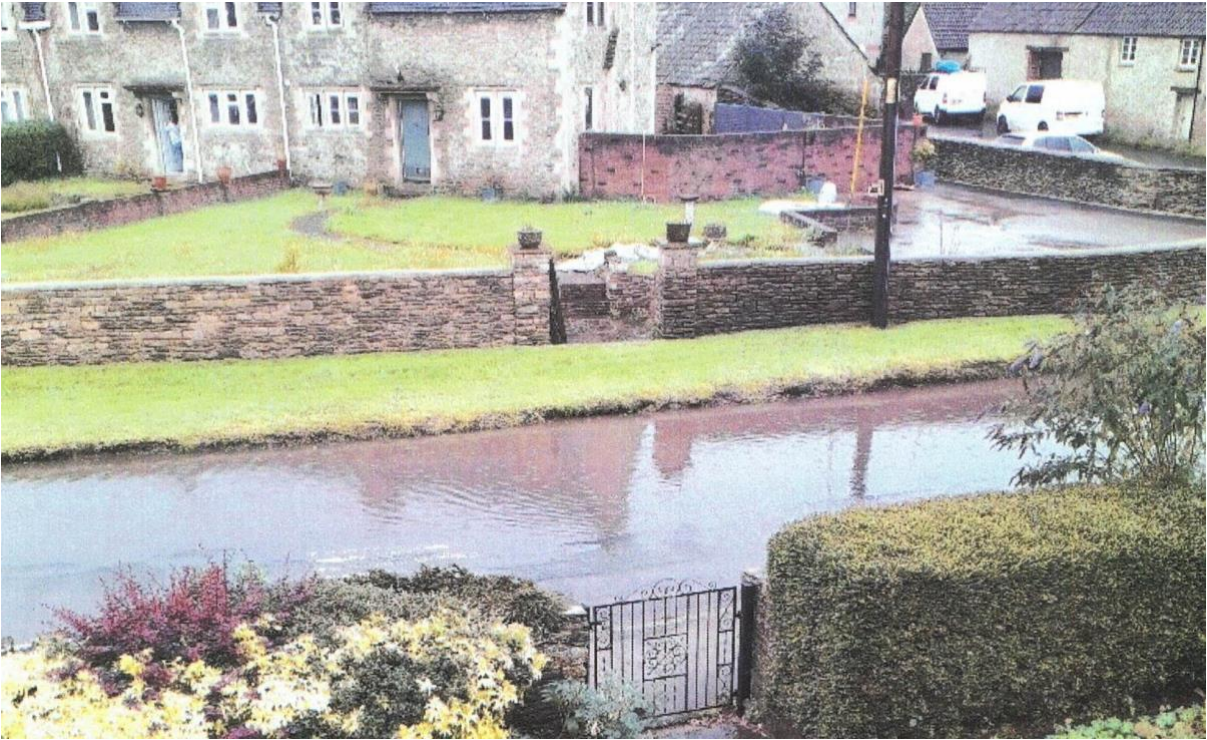
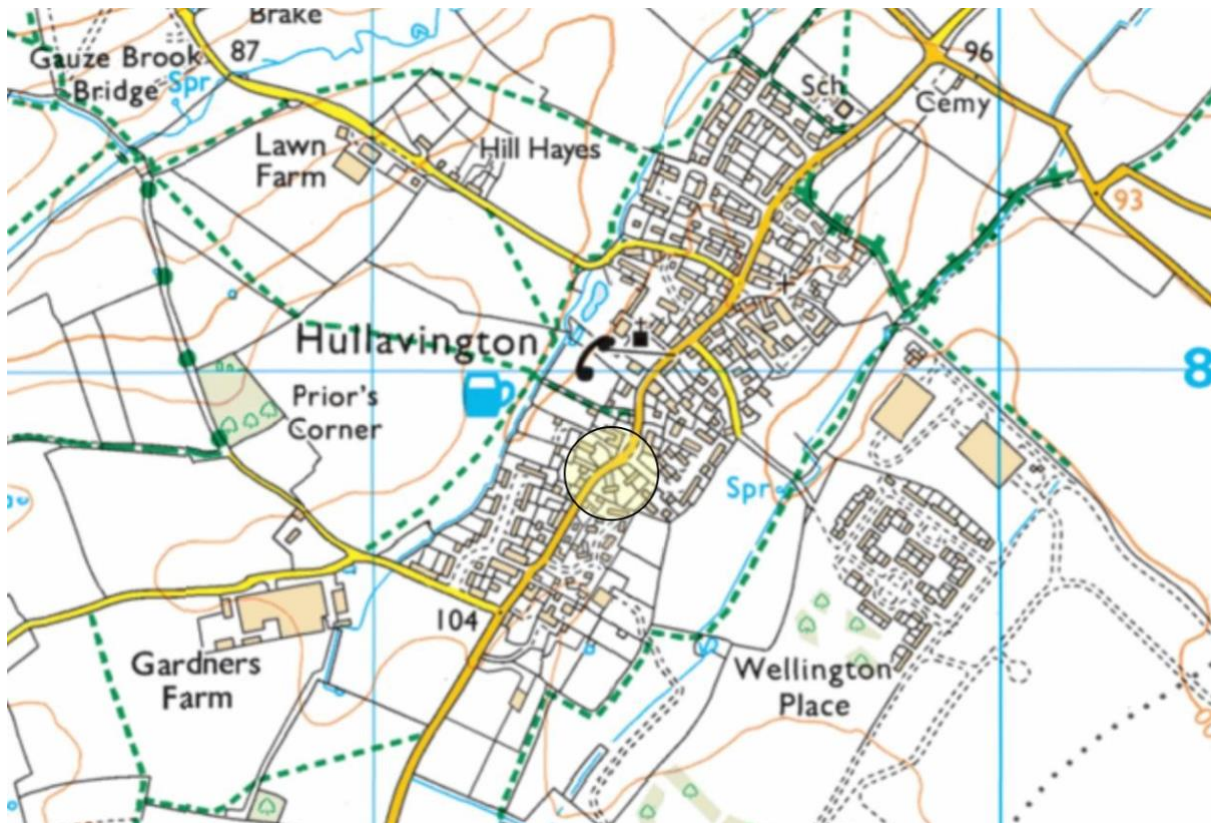
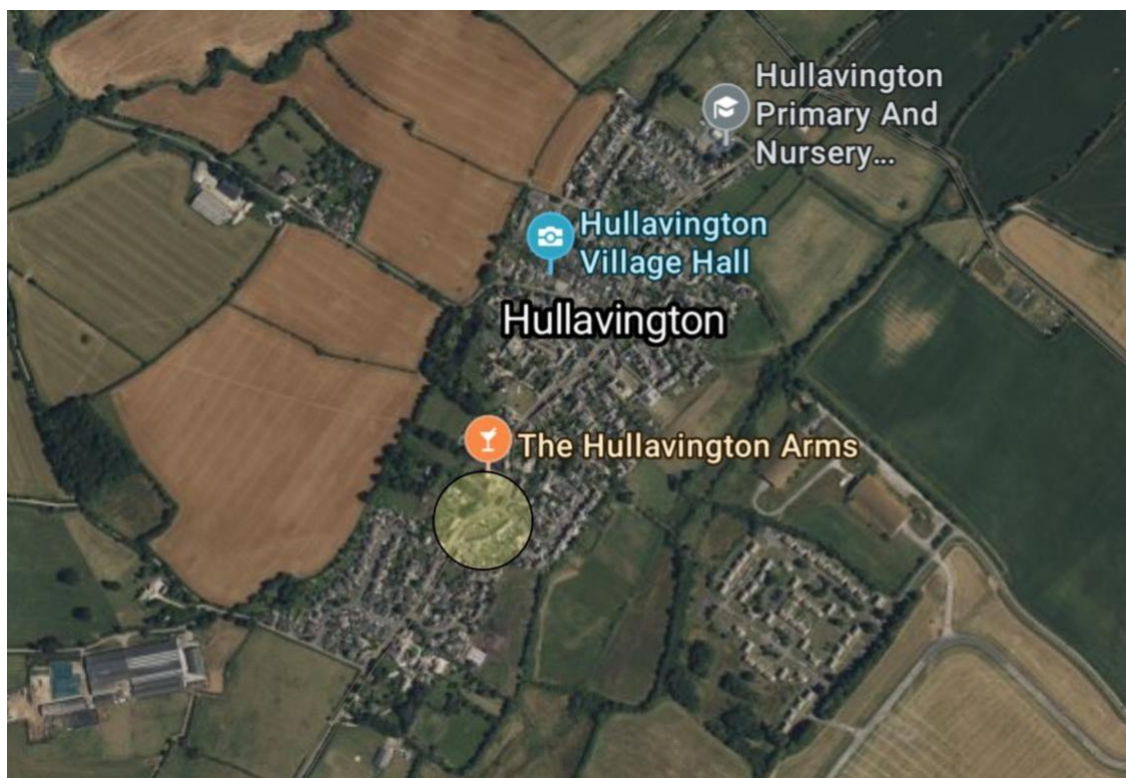
6.The Street

The issue here has been created by over-run of large vehicles, eroding the verge and blocking the gullies through vehicle flood wash. This now causes potholes and flooding of the road, even in relatively light rain. The road has been repaired on a number of occasions. The wash leads to blocked gullies which exacerbates the issue. Our Wiltshire Councillor for By Brook, Jon Atkey, attended on-site along with Nick Dye, Wiltshire Council Portfolio Holder for Flooding and Water Quality. The Parish Council is considering applying to LHFIF for a resolution. Suggested work is the insertion of kerbing and backfill of the verge. The drains were originally inserted into the verge in a similar way to the gullies that line the village green. The road will need repair and possible reinforcing to stop future subsidence and to direct water into the drains. A previous visit from a highways engineer recommended full height HB2 kerbs with a vertical face of at least 125mm.

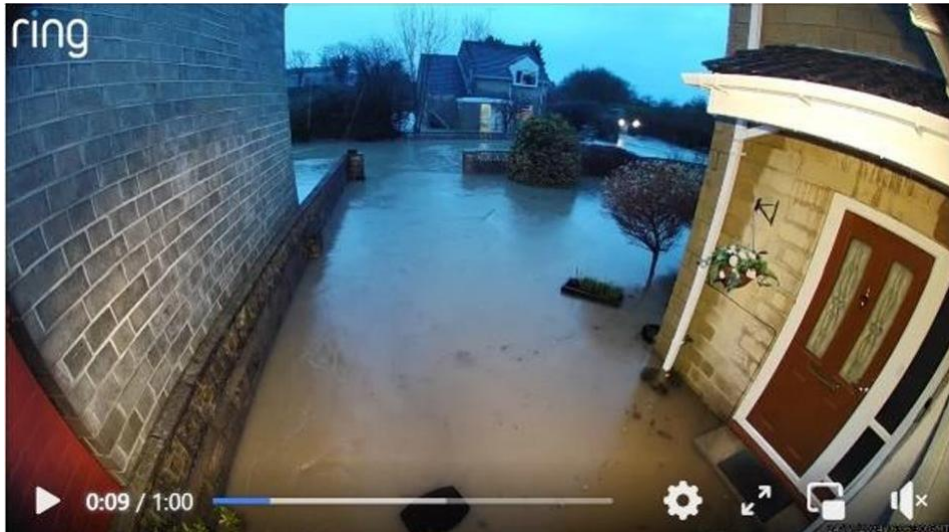
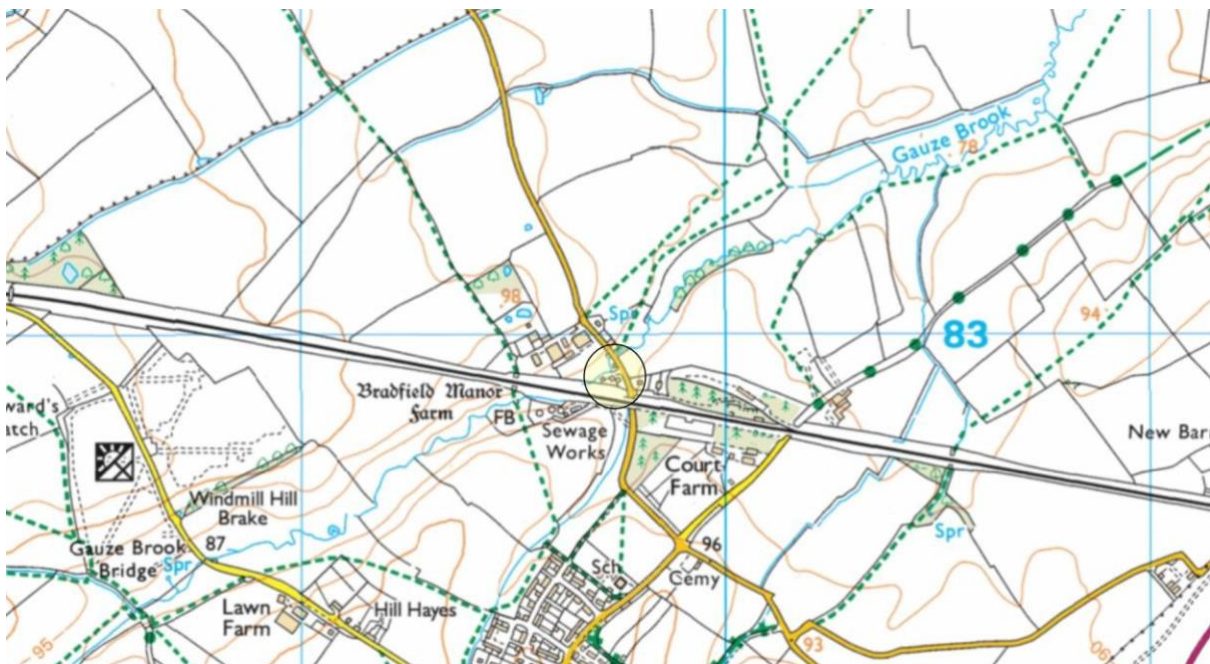
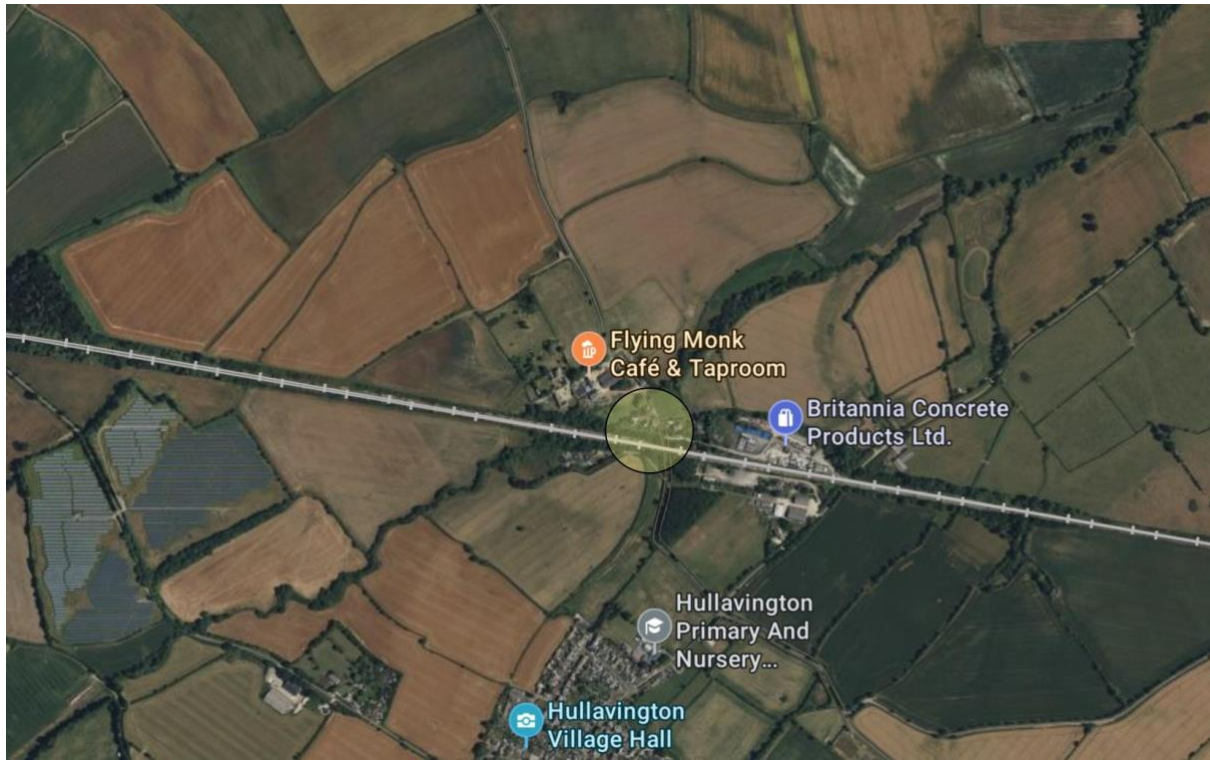
7. Brookside

In November 2024, during Storm Bert, the Gauze Brook burst its banks just north of the railway bridge on the road to Norton and two houses in Brookside were flooded. Cars that were able to drive through the floodwater on the adjacent road to Norton created waves, which added to the flood damage in Brookside. The flooding here was particularly concerning, not only because people's homes were flooded but also because of the risk, or likelihood, that the floodwater here was contaminated by overflow from the settlement tanks of the sewage treatment works immediately upstream of the Gauze Brook at this location.
