Hullavington Flood Sites

Compiled by Cllr Jon Atkey and Cllr Debbie Lawley

5 August 2025. Updated 11 September 2025

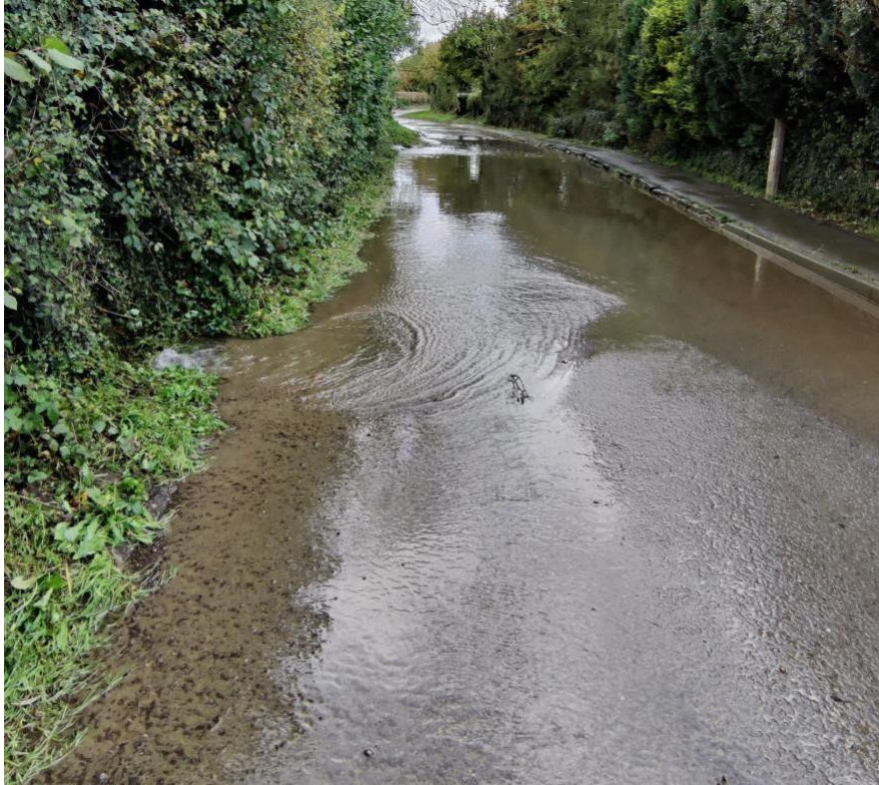
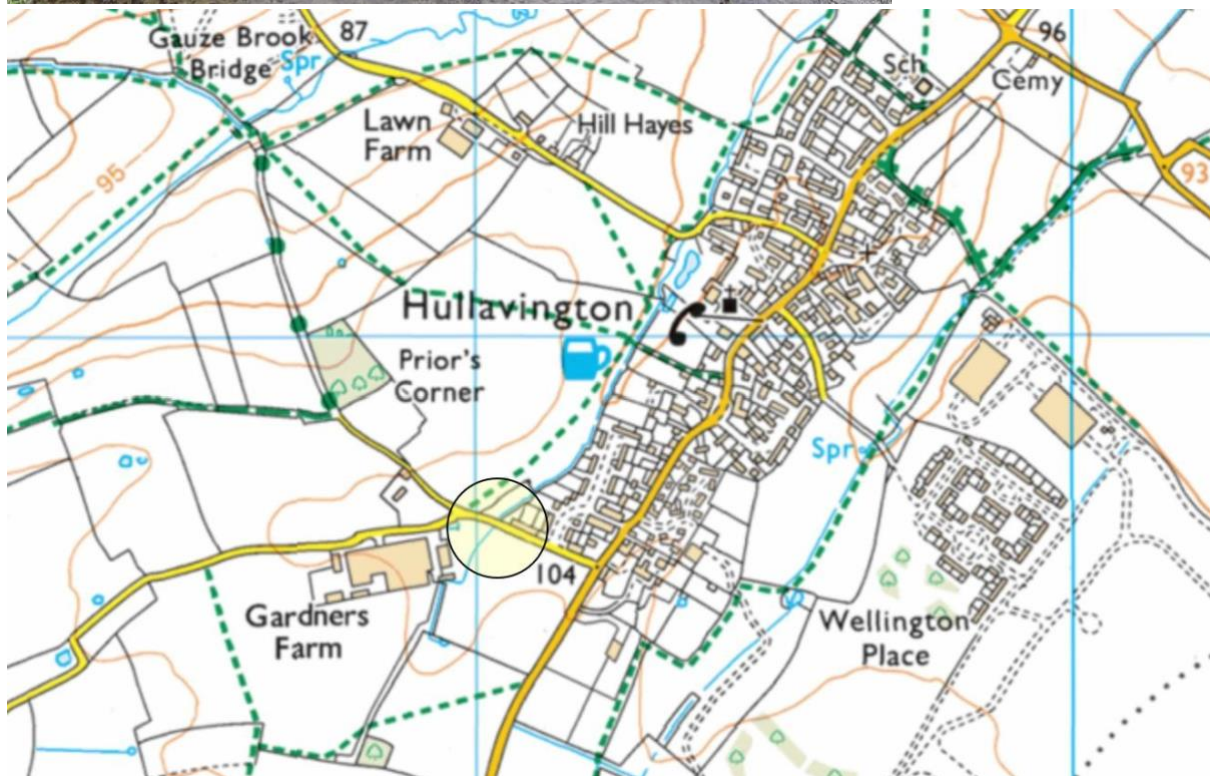
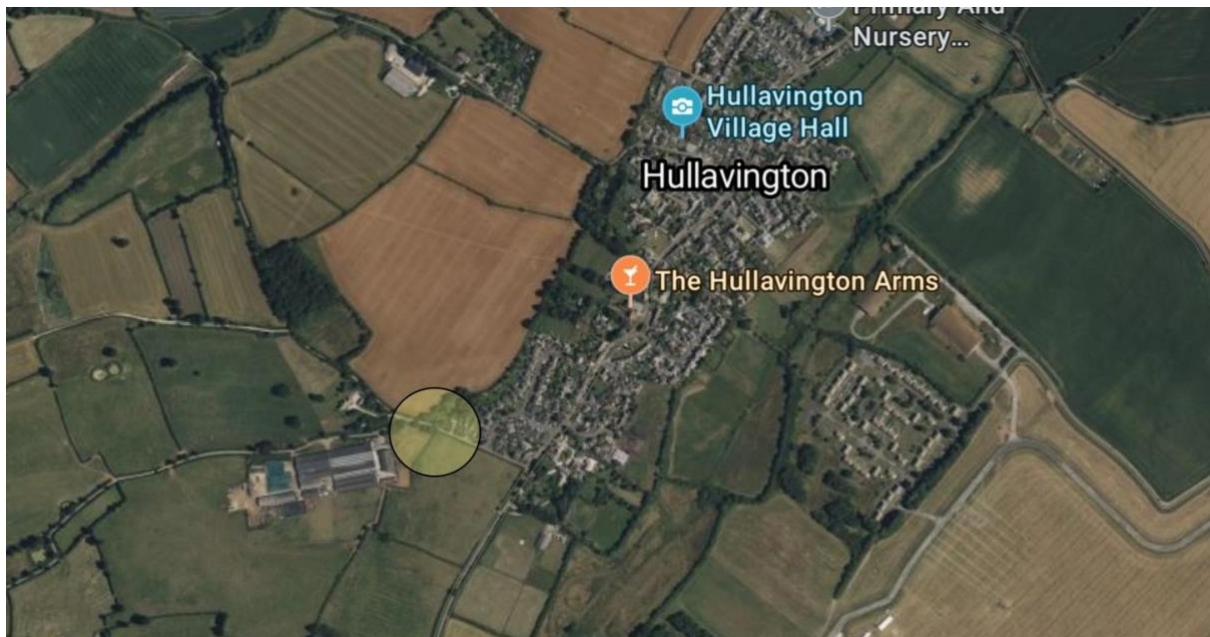
8.The ford at Parklands

A ford that can rise very high during storms, threatening to flood local homes
